AFFIDAVIT OF TOM MOORE

INSPECTION REPORT 8-12-02

An inspection was done on August 12, 2002 at a residential property at 354 Timber Road, Mt. Gretna, PA. The purpose of the inspection was to examine the house for moisture and water problems that possibly may have contributed to a mold and mildew condition resulting in the occupants having to move out of the house.

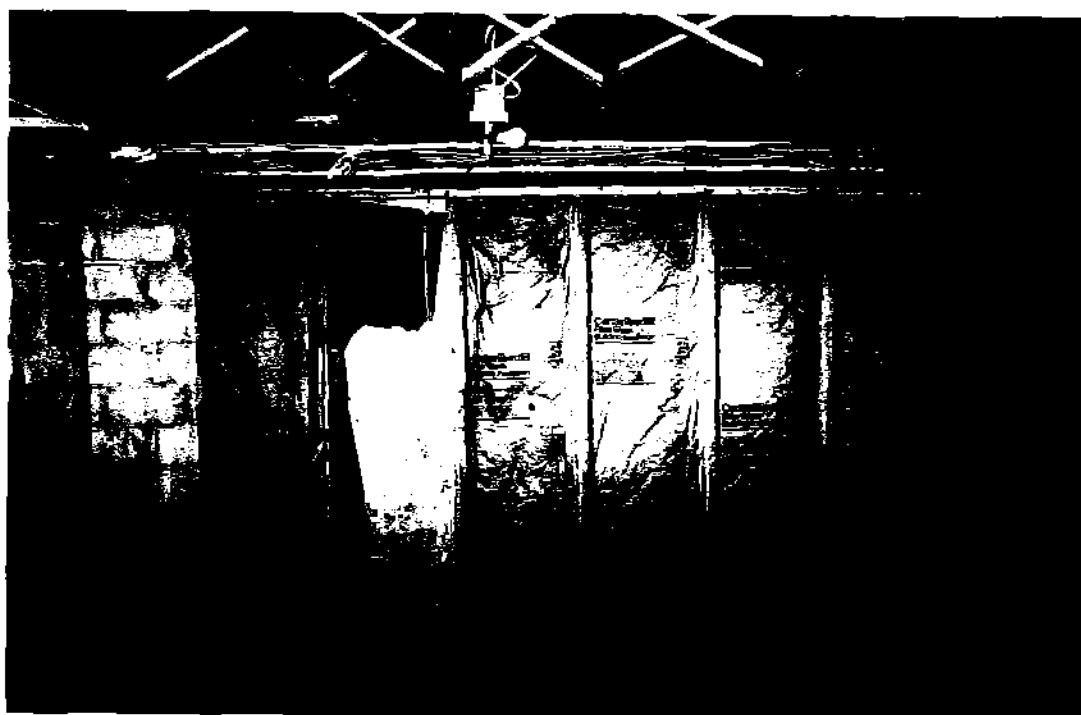
Photo # 31: This is a picture of the basement you will see in the foreground the electric junction box and part of the installation was removed the corner of the basement, if you are standing in front of the house that is the left side of the house
